### CONSOLIDATED SEWER MAINTENANCE DISTRICT CONDITION ASSESSMENT PROGRAM REPORT – CITY OF SAN DIMAS

**CONDITION ASSESSMENT REPORT**  
**COUNTY OF LOS ANGELES DEPARTMENT OF PUBLIC WORKS**  
**CONSOLIDATED SEWER MAINTENANCE DISTRICT**

PROJECT NAME:	Y0TV1112B	PROJECT MGR:	Hanna Kebede
PROJECT DATE:	07/17/13	CONTACT NO:	(626) 300-4686
SUP. DISTRICT(s):	5	MAP PAGE(S):	2343, 2385, 2386, 2387
Report By:	Hanna Kebede	Report Date:	5/1/17

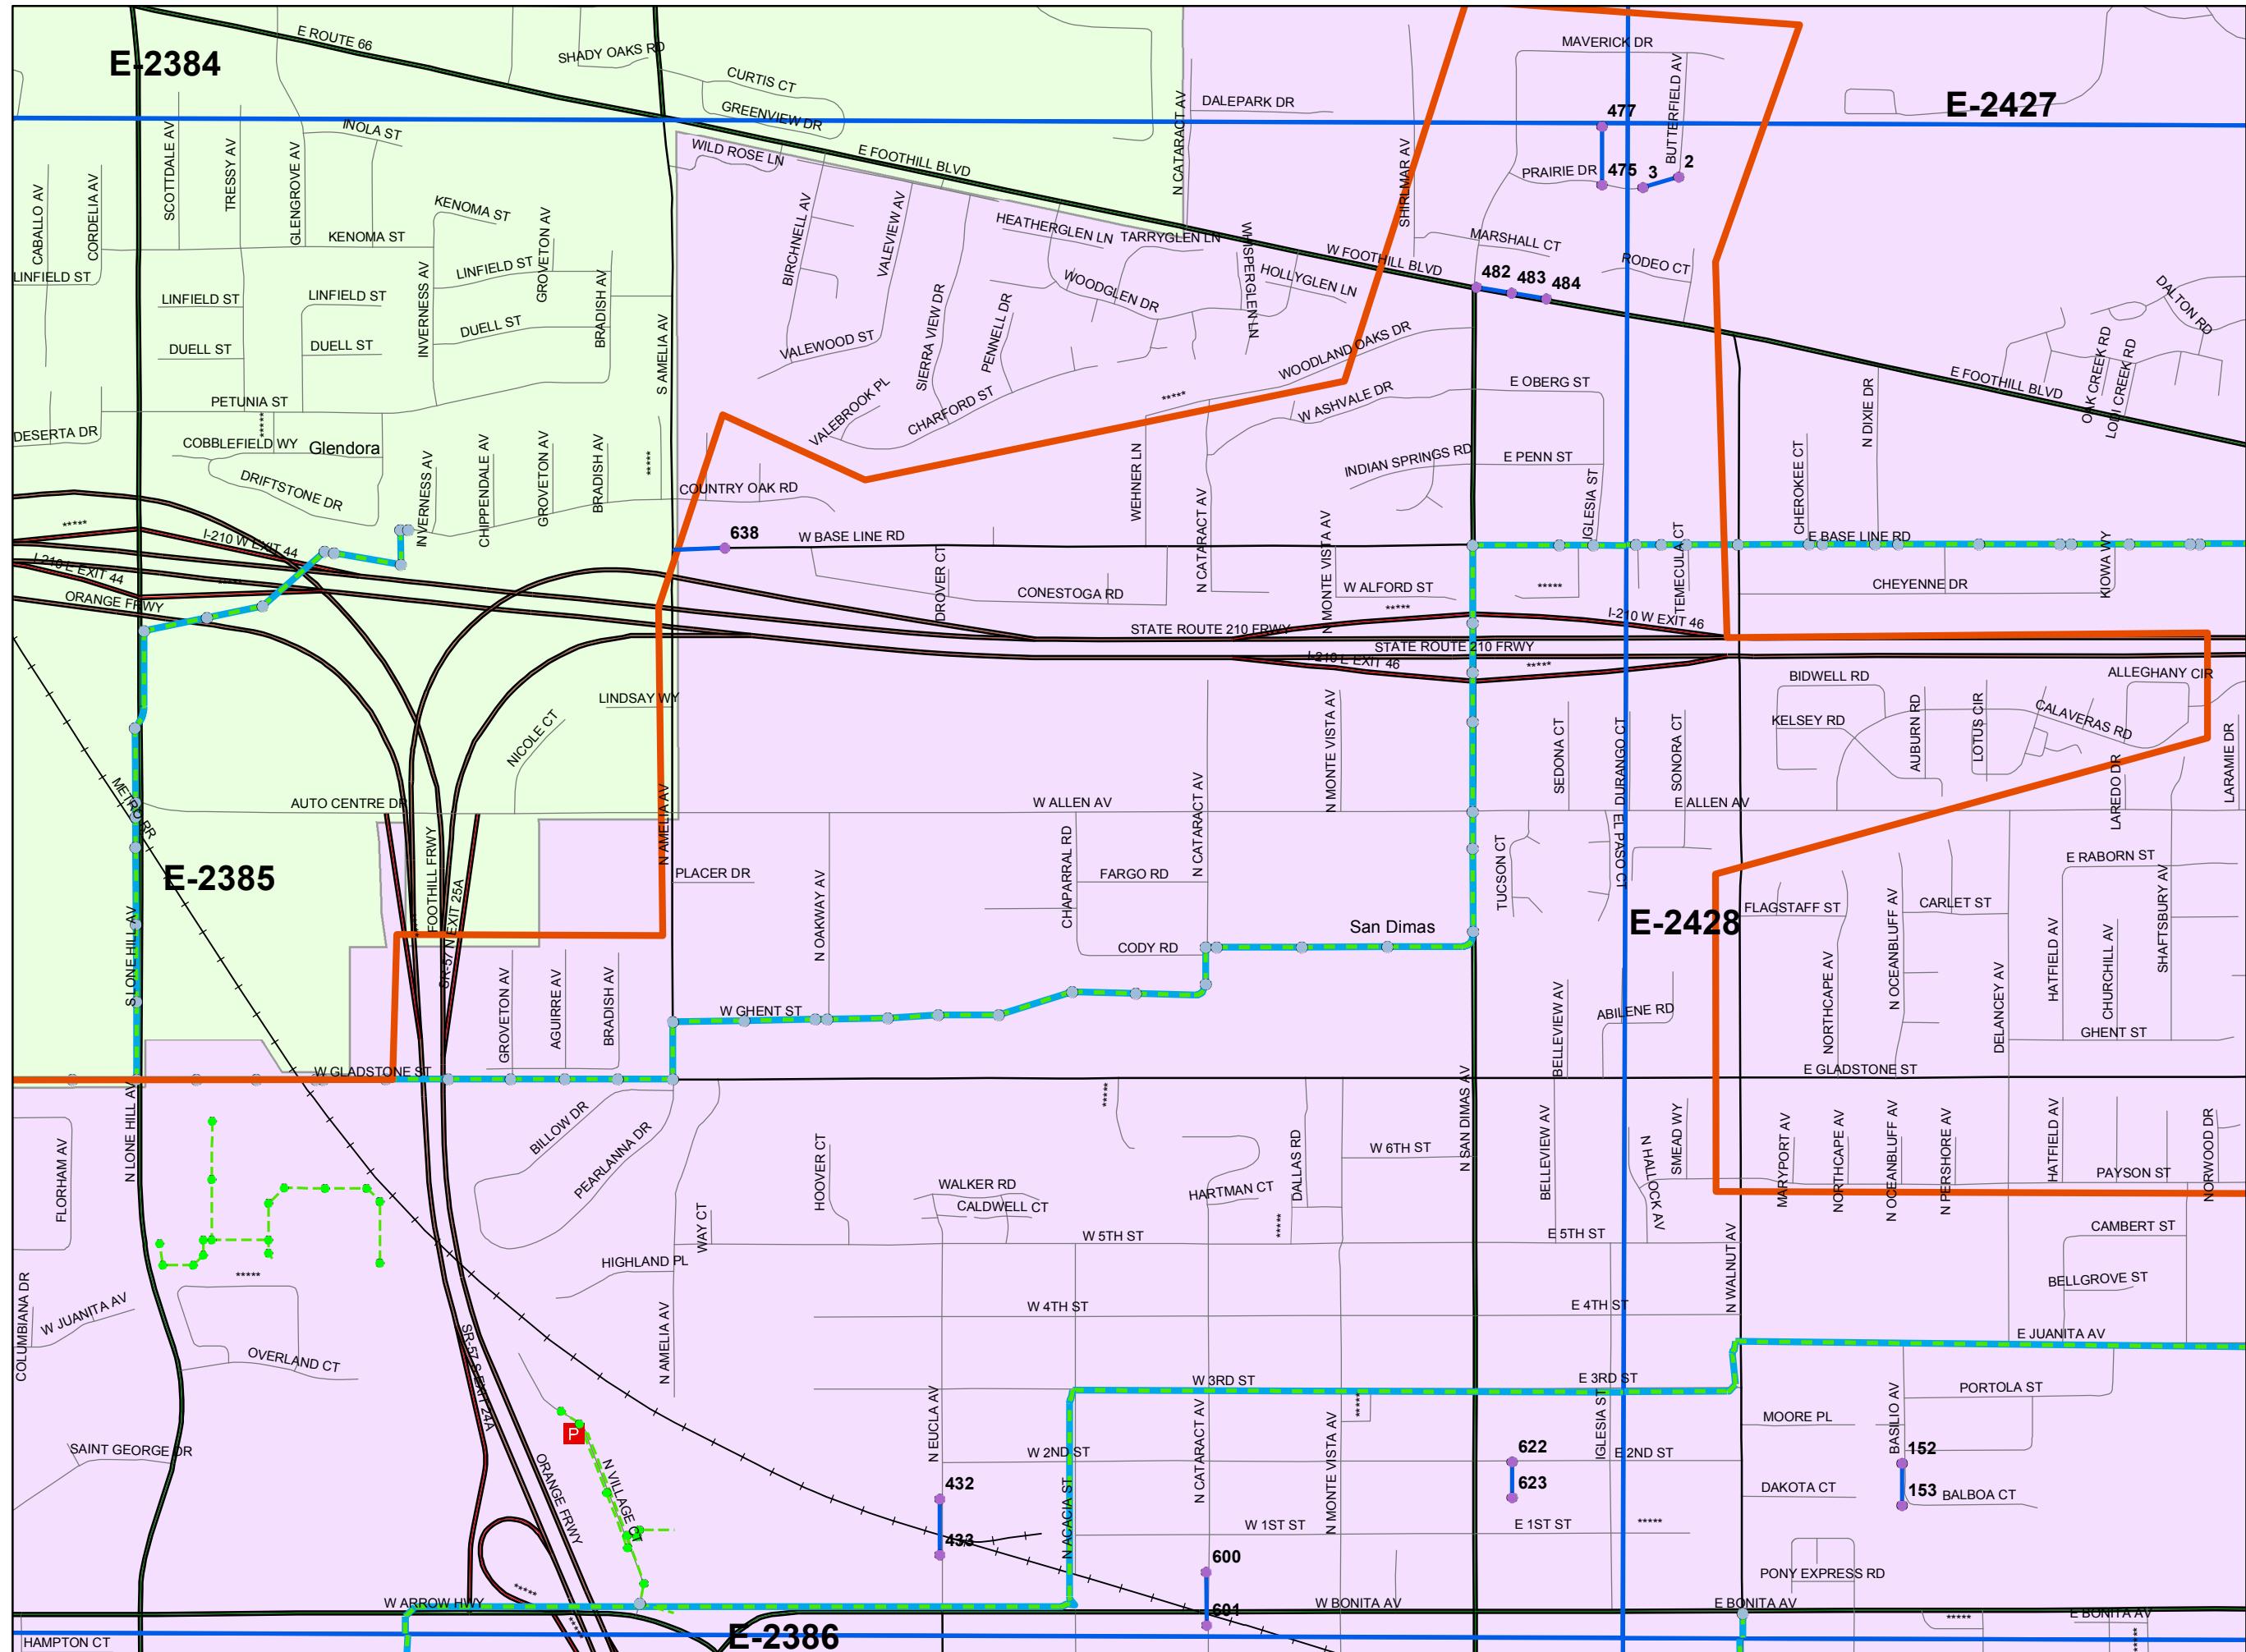
**ENCLOSURE 2**  
**HIGH WATER LEVELS**  
**CITY OF SAN DIMAS (Y0TV1112B)**

ITEM NO.	QMR	START MH	END MH	STREET	OBSERVATION	CORRECTIVE ACTION TAKEN (DATE COMPLETED)
1	412C	2343-0438	2343-0434	GREENWICH RD	Water mark (50%)	No action needed.
2	3122	2385-0432	2385-0433	EUCLA AV	Sag in pipe (45%)	Hydrojet (02/04/15)
3	4100	2385-0477	2385-0475	RED BLUFF CT	Water mark (50%)	No action needed.
4	5241	2385-0483	2385-0482	FOOTHILL BV	Water mark (50%)	No action needed.
5	5242	2385-0484	2385-0483	FOOTHILL BV	Water mark (90%)	No action needed.
6	412J	2385-0600	2385-0601	CATARACT AV	Water mark (90%)	No action needed.
7	412F	2385-0622	2385-0623	ALLEY	Water mark (50%)	No action needed.
8	4100	2385-0638	2385-0322	BASE LINE RD	Water mark (50%), roots, grease	Hydrojet (02/03/15)
9	4100	2386-0030	2386-0031	SMOKEWOODLN	Camera underwater; debris in line	Hydrojet (02/24/15)
10	4100	2386-0099	2386-0098	SAN DIMAS AV	Water mark (60%)	No action needed.
11	412D	2386-0286	2386-0287	ARROW HWY	Water mark (60%)	No action needed.

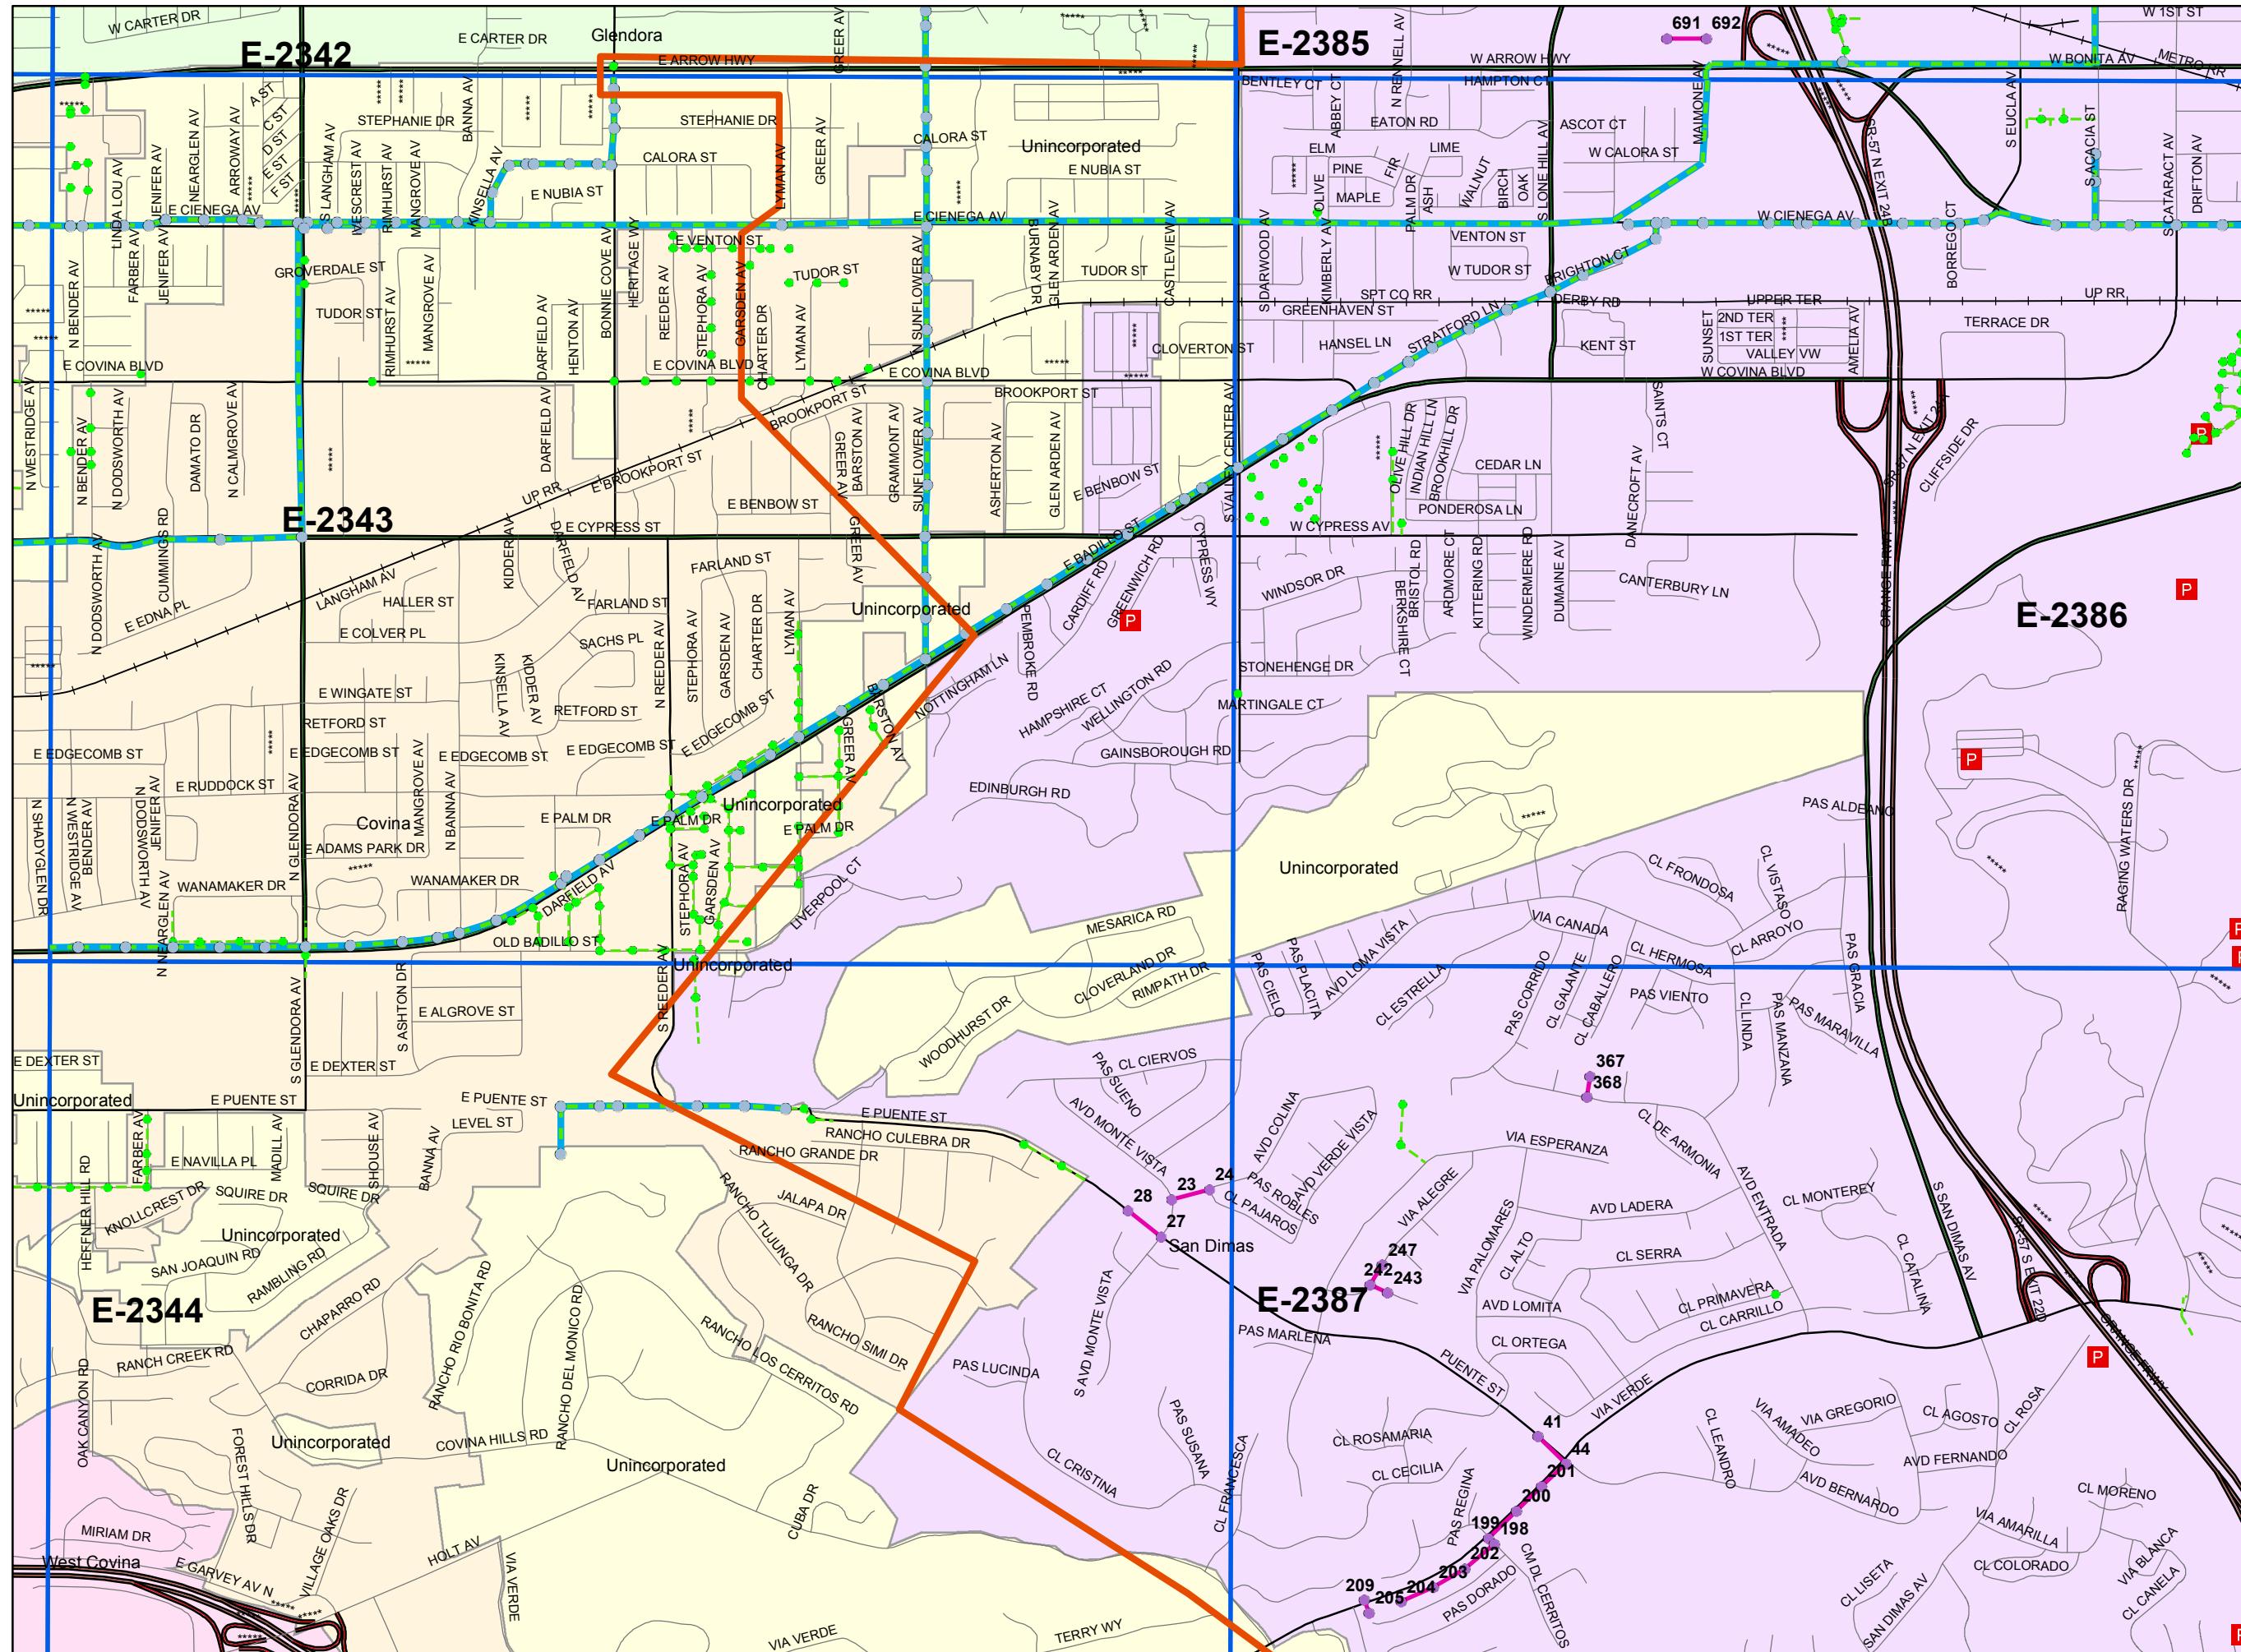
**ENCLOSURE 2**  
**INFILTRATION**  
**CITY OF SAN DIMAS (Y0TV1112B)**

ITEM NO.	QMR	START MH	END MH	STREET	OBSERVATION	PROPOSED CORRECTIVE METHOD
1	322V	2344-0024	2344-0023	AVENIDA COLINA	Infiltration (weeper): 226'	Infiltration is minimal. No action needed.
2	4132	2344-0027	2344-0028	PUENTE ST	Infiltration (dripper): 2'	Infiltration is minimal. No action needed.
3	312B	2385-0692	2385-0691	EASEMENT	Infiltration (weeper): 187'	Infiltration is minimal. No action needed.
4	4336	2387-0044	2387-0041	PUENTE ST	Infiltration (dripper): 12', 36', 88', 95', 150', 180	Lining: MH to MH
5	4121	2387-0198	2387-0199	CAMINO DEL CERRITOS	Infiltration (weeper): 33'	Infiltration is minimal. No action needed.
6	4132	2387-0199	2387-0200	VIA VERDE AV	Infiltration (weeper): 18'	Infiltration is minimal. No action needed.
7	4332	2387-0200	2387-0201	VIA VERDE AV	Infiltration (dripper): 0', 74'	Infiltration is minimal. No action needed.
8	312L	2387-0201	2387-0044	VIA VERDE AV	Infiltration (dripper): 170', 183'	Infiltration is minimal. No action needed.

9	422G	2387-0203	2387-0202	EASEMENT	Infiltration (runner): 91'	Infiltration is minimal. No action needed.
10	4231	2387-0204	2387-0203	EASEMENT	Infiltration (weeper): 128'	Infiltration is minimal. No action needed.
11	422C	2387-0209	2387-0205	VIA VERDE AV	Infiltration (weeper): 83', 90'	Infiltration is minimal. No action needed.
12	412C	2387-0243	2387-0242	PASEO ENCINAS	Infiltration (runner): 121'	Grout Injection
13	412M	2387-0247	2387-0242	VIA ALEGRE	Infiltration (weeper): 203'	Infiltration is minimal. No action needed.
14	4100	2387-0367	2387-0368	CALLE ESPANA	Infiltration (runner): 84'	Infiltration is minimal. No action needed.
15	412L	2387-0202	2387-0198	EASEMENT	Infiltration (runner): 274'	Infiltration is minimal. No action needed.
